**WG8 on:  
METAL SPATIAL STRUCTURES**

**Vol. 64 (2023) No. 2**

# SCALED SHAKING TABLE TESTS SIMULATING THE DAMAGE OF THE SCHOOL GYMNASIUM IN THE 2016 KUMAMOTO EARTHQUAKE

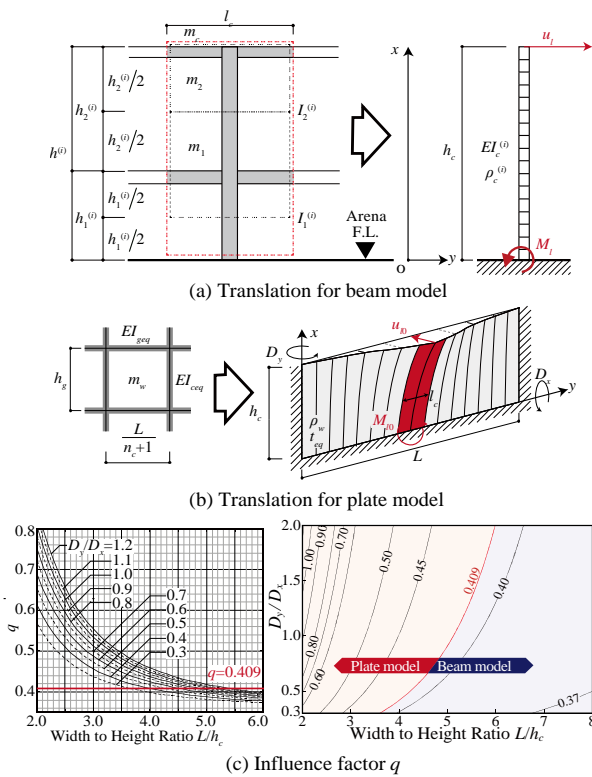
**Figure 8:** Schematic illustration of the out-of-plane response evaluation method [18]

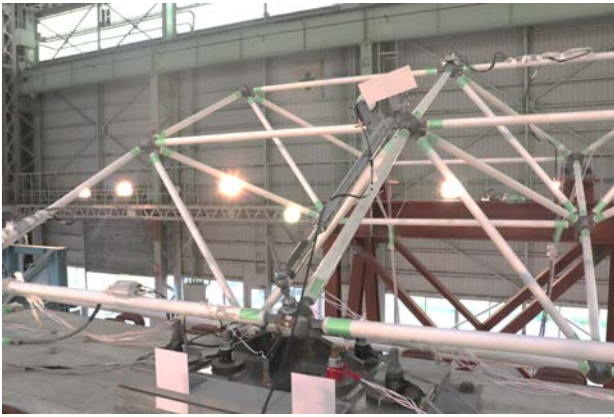
Figure 10: Measurement detail around the roller support

The response acceleration on the shaking table and the RFL of the RC moment frame are primarily measured in the experiments, along with the displacement of the RC moment frame, the relative displacement and reaction force of the roller support, the axial deformation and force of the upper chord connected to the roller support, and the axial strain and force of the other roof truss members connected to the roller support. The measurement detail around the roller support is shown in Fig. 10. The laser displacement sensors are assigned to measure every displacement response. The axial force of the roof member is computed by the section area, young's

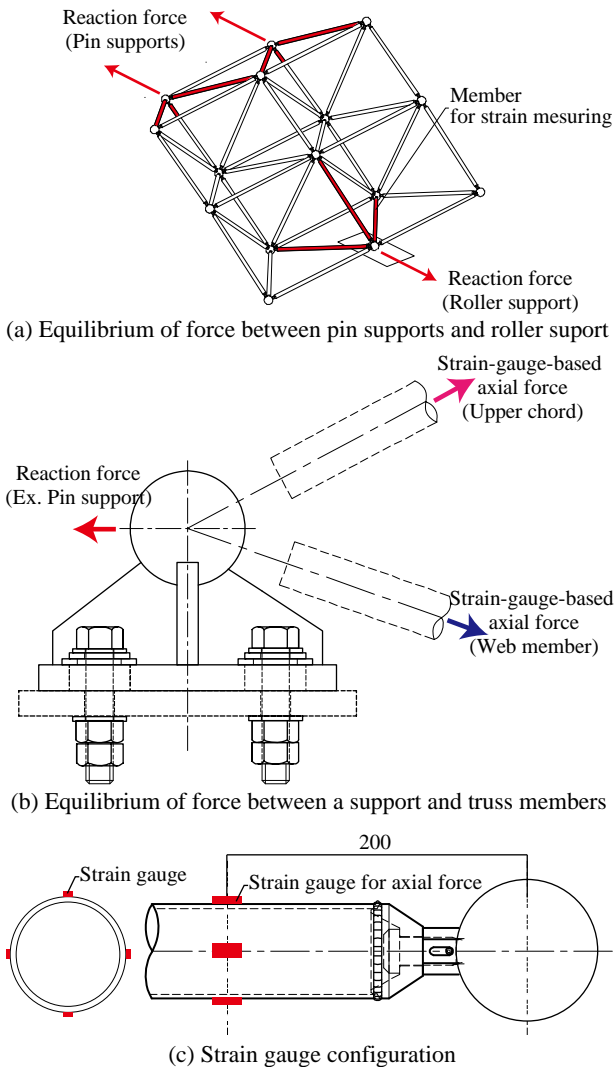
Figure 11: Schematic illustration of load measurement

modulus, and the measured axial strain. The schematic illustration of the load measurement is shown in Fig. 11. The total reaction force of the pinned supports on the frame jig is equal to that of the roller support, and it is computed as the total axial force of the roof truss members connected to the pinned supports. The axial force of the upper chord connected to the roller support is computed as the difference between the reaction force of the roller support and the total axial force of the other roof truss members connected to the roller support. This measuring plan is adopted based on the preliminary experiment (Fujiwara et al. [23]) and numerical simulation. The time history and spectra of input wave is shown in Fig. 12. The scaled floor response acceleration on the arena of Gym. A was used as the input wave. The floor response acceleration was

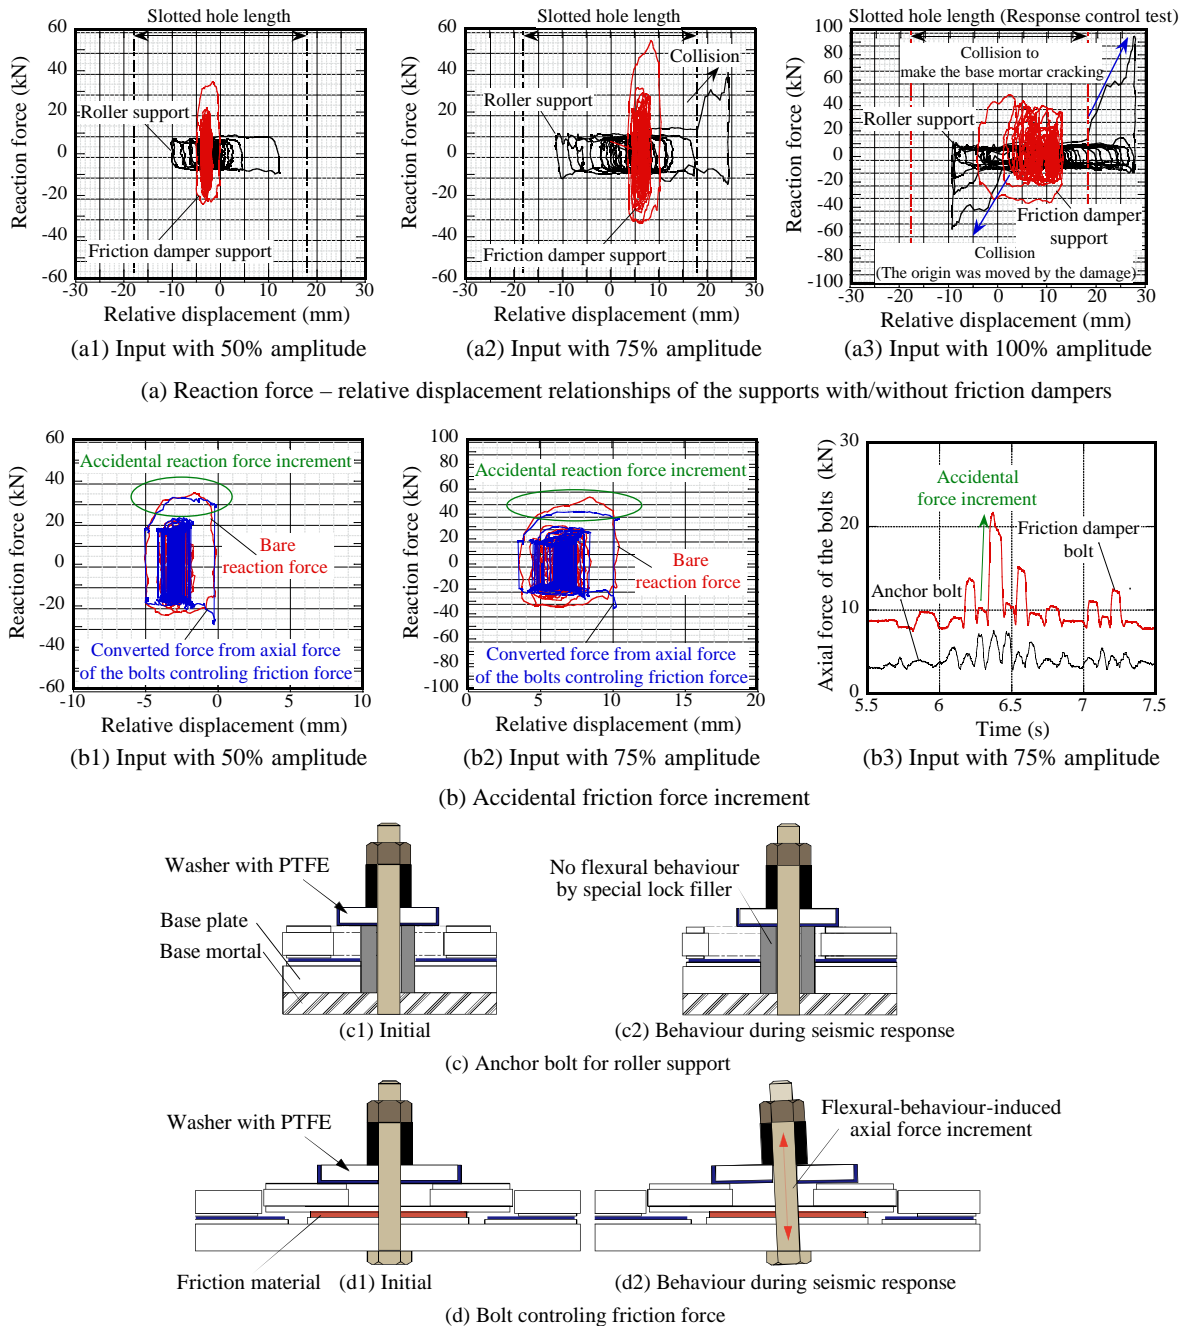
Figure 13: Response control testing results

The reaction force–relative displacement relationships of the roller support with and without the friction damper are shown in Fig. 13(a). The transverse out-of-plane response of the RC moment frame was significantly mitigated by the friction damper, and the relative displacement of the roller support is reduced less than the length of the slotted hole ( $\pm 18$  mm). The origin of the slotted hole was moved by the base mortar cracking in the input with 100% amplitude for the response with the roller support without friction dampers, as shown in Fig. 13(a3).

The friction force of the damper accidentally increased over the designed value during the seismic response. The converted force from the axial force of the bolts controlling friction force and the friction coefficient of 0.85 obtained from the friction material test accurately matched the bare reaction force, as shown in Figs. 13(b1) and 13(b2). This indicates that the bolt controlling friction force at the damper rotated during the seismic response, as shown in Fig. 13(d). Furthermore, the axial force of the bolt increased as shown in Fig. 13(b3). These results indicate that the friction damper’s detail could be improved. Nevertheless, the experimental results demonstrate the effectiveness of the response control method proposed by Narita and Terazawa et al. [10], which uses friction dampers.

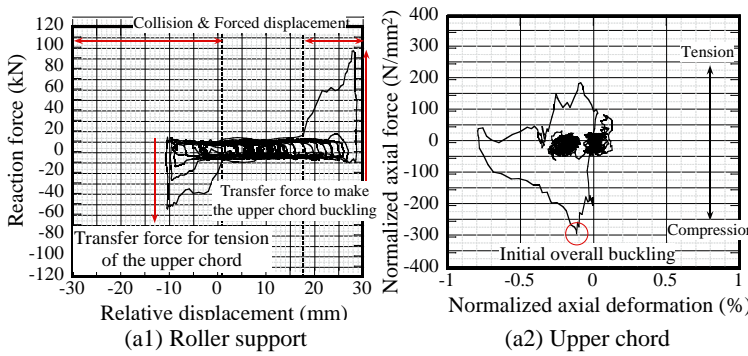
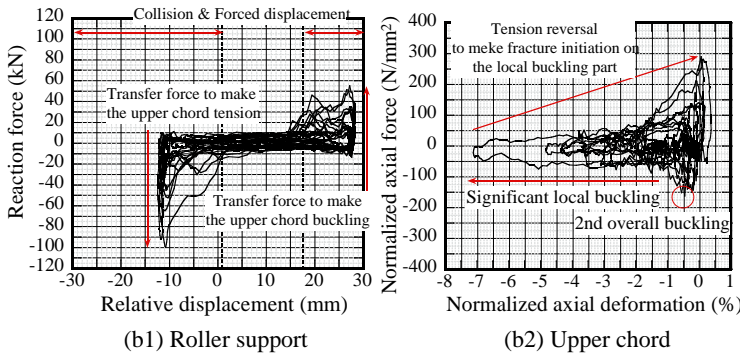
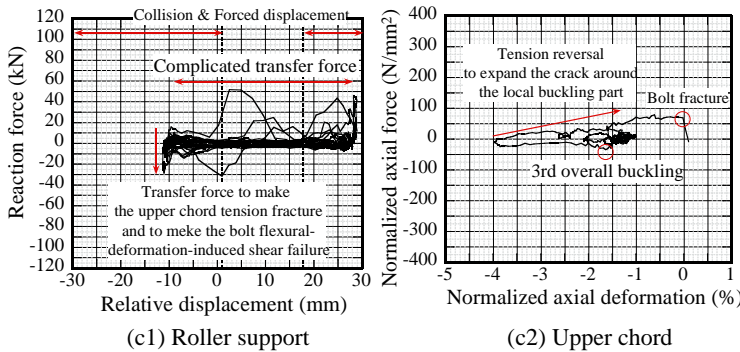
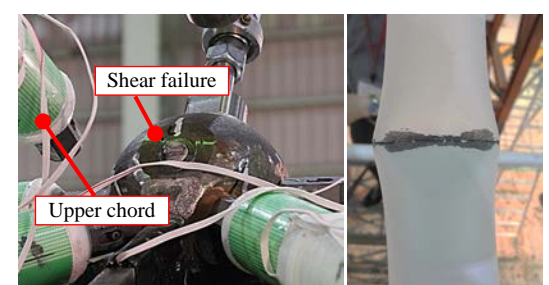
(a) The 1st input with 100% amplitude

(b3) Local buckling (b4) Flexural yielding of RC column

(b) The 2nd input with 150% amplitude

(b5) Collision of diagonals of truss (a screen shot from video)

(c) The 3rd input with 150% amplitude

(c3) Bolt fracture (c4) Crack propagation

Figure 15: Collapse testing results

The reaction force – relative displacement relationships of the roller support, normalized axial force – deformation relationships of the upper chord, and the damage situations are shown in Fig. 15. The anchor bolts of the roller support were contacted at the end of the slotted hole by the out-of-plane response of the RC moment frame in the first input with 100% amplitude, as shown in Figs. 15(a1) to 15(a2), and the roller support then experienced forced displacement. The transverse out-of-plane response-induced inertia force of the RC moment frame was transferred to the roof through the roller support, resulting in the overall buckling of the upper chord. Flexural yielding occurred in the RC column base in the second input with 150% amplitude, as shown in Figs. 15(b1) to 15(b5). The upper chord's normalized axial deformation reached around 7% before experiencing local buckling and fracture initiation. Furthermore, the entire roof structure began to vibrate vertically after the upper chord's load-bearing capacity was lost, and the diagonals of the truss connected to the roller support collided with the RC beam numerous times. As shown in Figs. 15(c1) to 15(c4), the connection bolt experienced flexural deformation-induced shear failure in the second input with 150% amplitude, while the crack was expanding around the local buckling part of the upper chord before the gross section fracture occurred. The fourth input was canceled for safety reasons. The collapse test indicates the transverse out-of-plane response of the RC moment frame is the main cause of the subsequent damage to the school gymnasium and validates the damage mechanism proposed by the numerical simulation [15].

The evaluated rotational stiffness of the connection of the upper chord is 7.96 kNm/rad., and the corresponding effective length factor is 0.71. The evaluated buckling strength considering the yielding stiffness of 409 MPa obtained by the material test was approximately 72 kN accordingly. The experimental buckling strength was 66.7 kN. The method proposed by Terazawa and Kishizawa et al. [17] evaluates the experimental result within the error of 6 kN. Compared with the 49 kN of buckling strength with the pin-pin connection used in the usual design standard, the evaluation value was close to the experimental result and is suitable
